EXHIBIT D

Calibration Report

Hydrologic modeling to support Hydromodification Management Plans: Evaluation and calibration of the San Diego Hydrology Model to reference watersheds in San Diego

Draft date: June 29, 2015

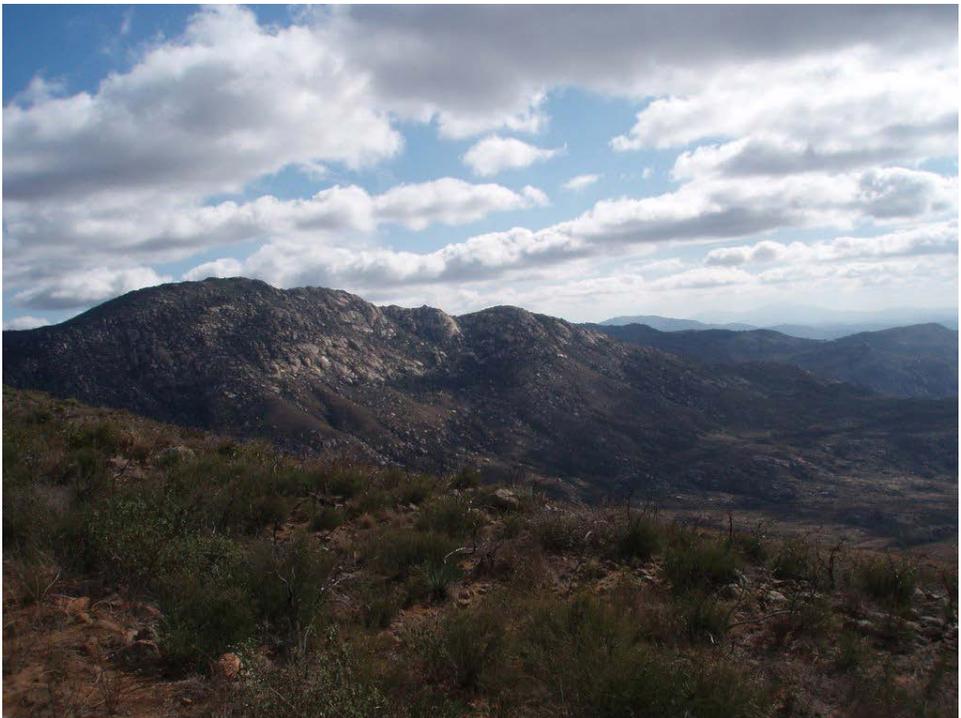
Figure 3. Photograph from the summit of Rodriguez Mountain on the northern boundary of the Guejito watershed. Photo credit C. Foster. Note the high soil fraction in the foreground and steep bedrock outcrops.

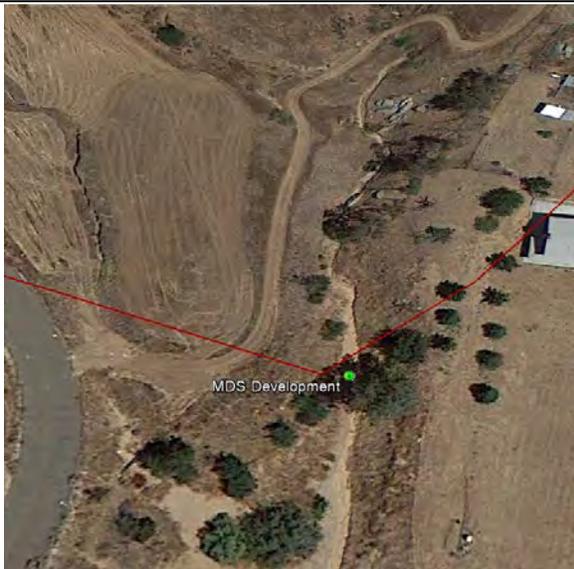
2010 – Narrowing of the creek and vegetation growth near the monitoring site.

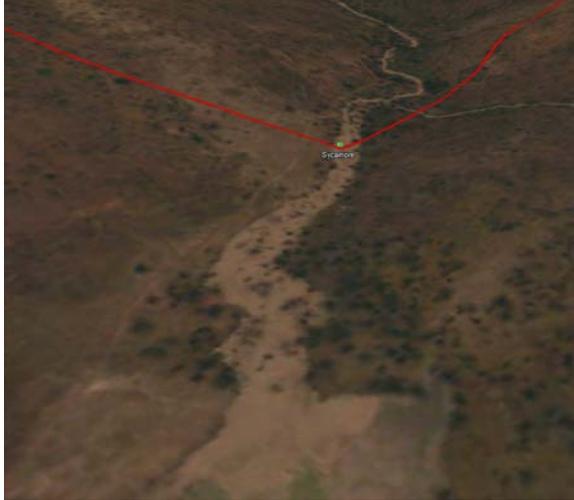
2005 – Floods have flushed fine sediment from the upper watershed, widening the channel and filling the downstream stock pond.

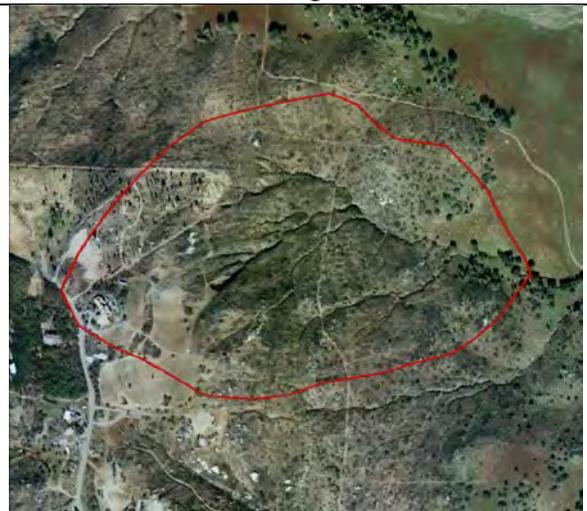
2008 – Much of the watershed was burned during the Witch Creek Fire. Channels may have incised.

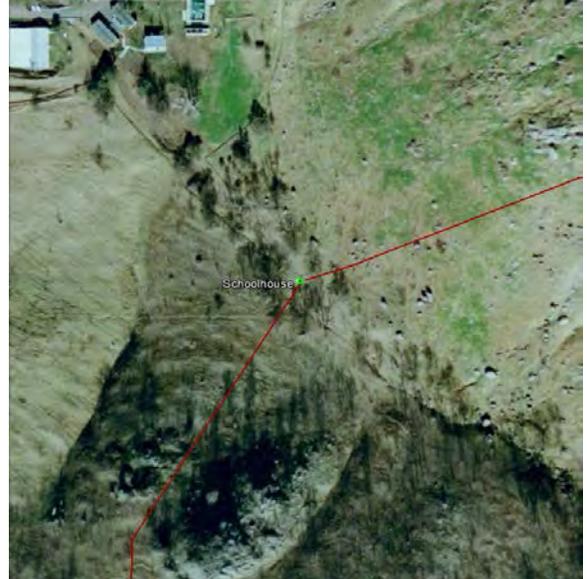
2008 – The vast majority of vegetation was burned during the Witch Creek Fire, and eroded sediments deposit in the channel near the monitoring site.

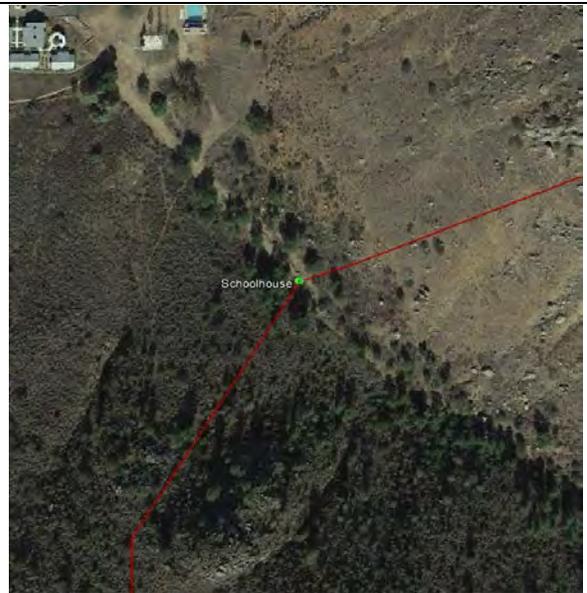
2013 – Vegetation has continued to recover and the channel has narrowed. Sediment is still being flushed from the watershed.

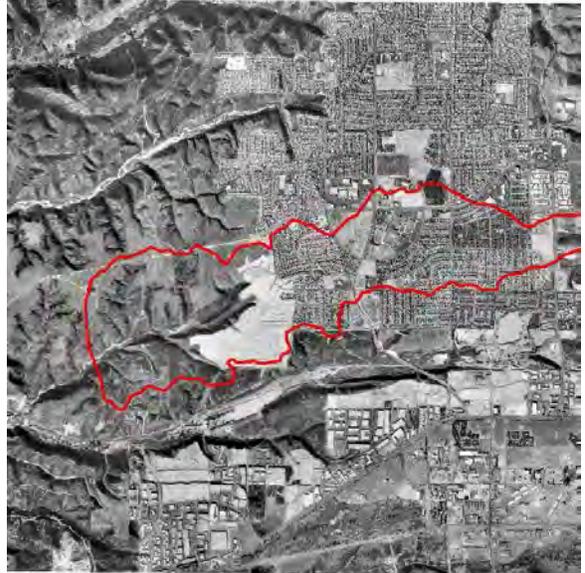
1980 – The majority of the upper watershed has
been culverted, filled, and developed.

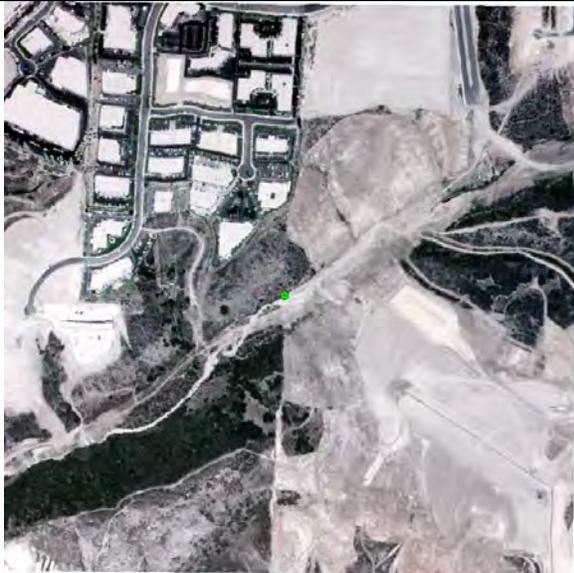
1989 – Grading associated with the construction of Camino Santa Fe and development projects has directly modified the creek and watershed.

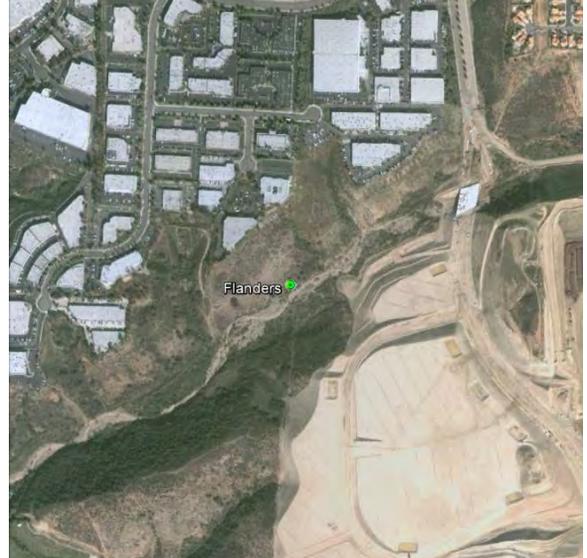
2003 – The channel narrows as a low flow channel develops and the floodplain is revegetated.

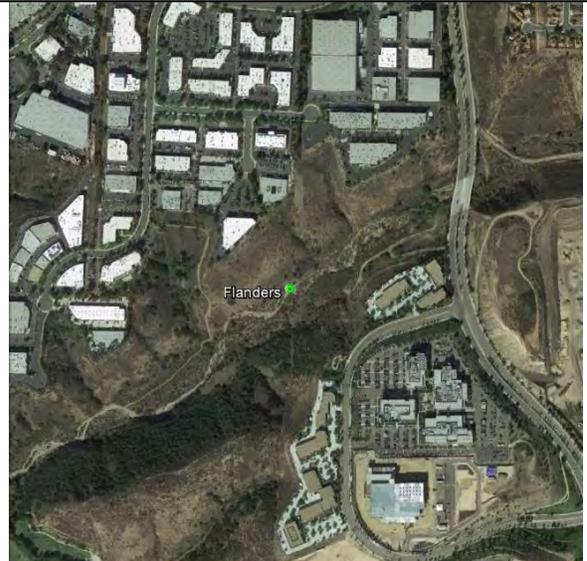
2014 – Today the creek alternates between reaches of well-connected channel and floodplain, and small braids with vegetated bars.
